Service Bulletin # 09-11

BREAKER WIRE INSPECTION

☒ NewEra XC ☐ FleetMax ☐ Commander ☐ Legend 138 ☐ Legend 158 ☐ Classic ☐ Bus

Vehicles affected: 62725 through 62790

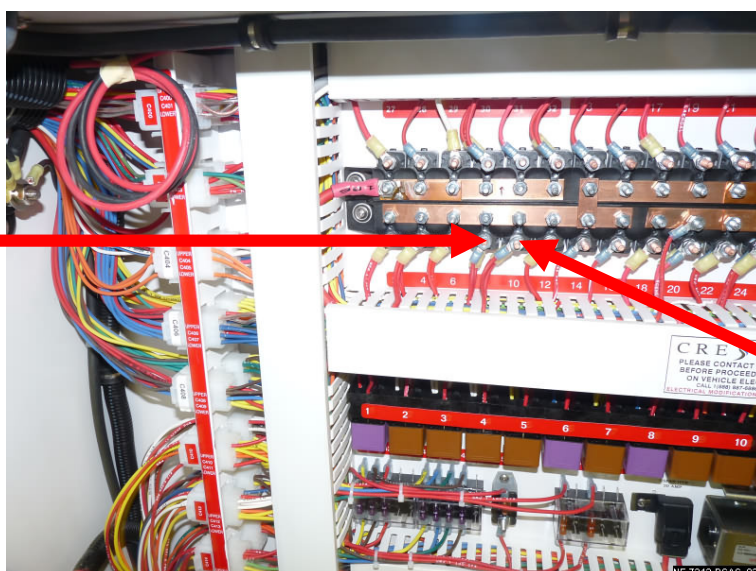
Fig 1 View of circuit breakers

This intention of this bulletin is to confirm the correct routing of wires #58 (Thermo Power) and #154 (Right Bank Cot Lights), each located in the ecc. There have been reported incidents of the #58 wires being attached to the incorrect circuit breaker #10 which overloaded the breaker, causing it to trip. Please ensure that the #58 Thermo Power wires are attached to the #8 circuit breaker, and the #154 Right Bank Cot Light wires are attached to the #10 circuit breaker.

#8 breaker. Confirm #54 Thermo Power wires are attached here.

#10 breaker. Confirm #154 Right Cot Light wires are attached here.
