BC Ambulance Service BC Emergency Health Services	Crestline Ford Remount Front Switch Panel Backlighting Modification	January 8, 2018 Page 1 of 1
AMBULANCE TYPE:	Crestline Ford Remount Ambulance	
UNITS AFFECTED:	Crestline Ford Remounted Ambulances 63380 to 63389

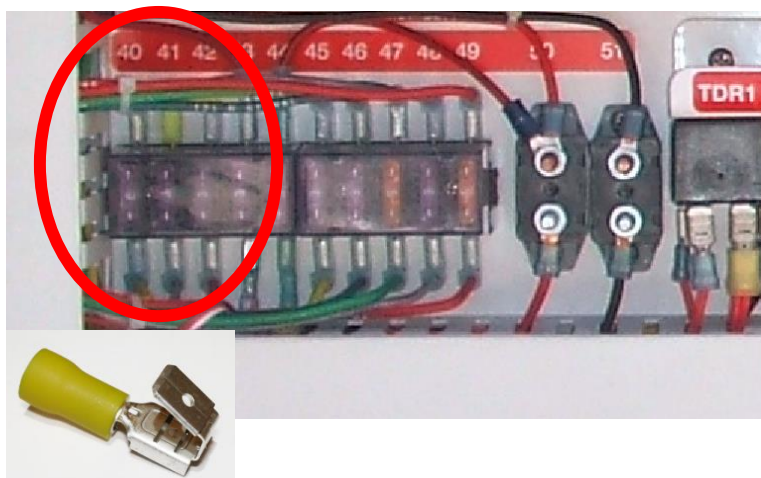
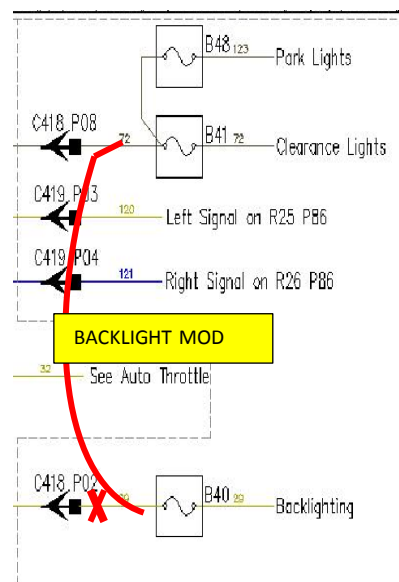
ISSUE: The Crestline added circuit for the front switch panel backlighting may be causing the Ford Smart Junction Box (SJB) to fail. If the SJB circuit fails, the backlighting for the OEM gauges will fail as well.

ACTION: Check the function of the backlighting for the OEM gauges. If the OEM backlighting has failed, diagnose the concern and repair, and then perform the following modification. Remove the power supply for the backlighting circuit and re-supply it with the clearance light circuit power.

1. Locate the fuses numbered 40 and 41 in the ambulance side electrical panel.
2. Test these fuses to find the wires supplying power to the fuses (unplug a wire from each fuse and using a test light check for power at the wire or fuse terminal to determine the power supply wire – the clearance lights must be turned on).
3. Unplug the power supply side of fuse #40. Insulate the wire and leave disconnected.
4. Make up a jumper wire using a spade splitter terminal to plug onto the power supply wire to fuse #41 and jump to the fuse #40 input terminal. (If a splitter terminal is not available, splice the jumper wire to the power source wire for fuse #41).
5. Attach a label stating “BACKLIGHT MOD” to the jumper wire to mark that this modification has been performed.
