Service Bulletin # 09-07

POWER SEAT BASE WIRING ROUTING AND SECURITY

Units affected include: 62725 through 62790 Chevrolet Ambulances only

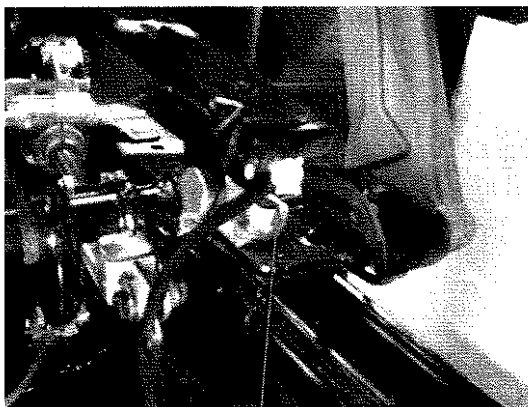
Fig. 1

This bulletin is to address potential damage and short circuits that can occur due to improper wire routing in the added driver's power seat base on 2009 Chev. Crestline Ambulances.

Drill hole in rear flange of aisle side mounting plate. Shown is the nylon tie through the drilled hole, securing the seat belt buckle harness.

5. Drill a 3/16" hole in the end of the aisle side mounting plate. (Fig. 1)
6. Drill a 3/16" hole in the horizontal flange of the rear plate of the OEM seat base (Fig.2)

7. Route the seat belt buckle switch wire harness as shown to the aisle side mounting plate and secure with a supplied wire tie (Fig.1)
8. Move the seat base all the way forward, then gather and tie the remaining seat belt buckle harness and tie to the seat base with a supplied wire tie passing through the hole in the flange on the rear plate of the OEM seat base. (Fig. 2)

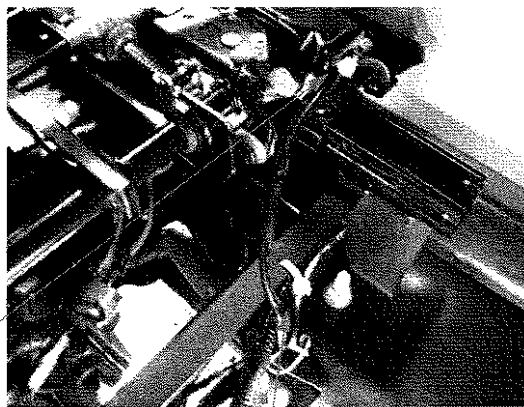
Fig. 2

Drill hole in flange on rear seat base plate. With seat base travelled all the way forward, collect & tie remaining harness.

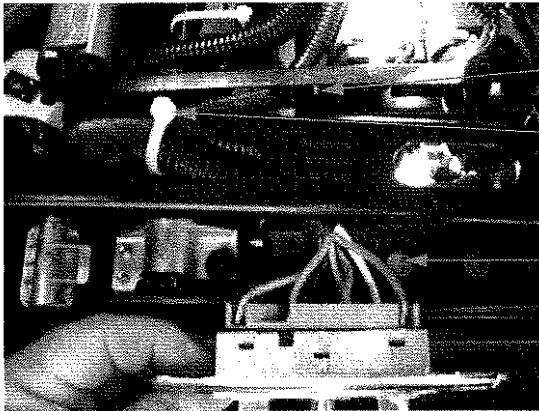
Fig. 3

Pass both
harnesses
through oval
hole.
Tie #3

Locate 6 way
controller as shown &
tie both harnesses to
seat mounting flange

9. Apply the supplied split loom to the Orange and Black wires running to the 6 way controller.
10. Route both harnesses from 6 way controller into seat base under left outer mounting plate and through the adjacent oval hole in internal seat base structure. (Fig. 3) Position 6 way controller approx. 3" from left outer mounting plate, locate as shown in Fig. 3, relative to the stamping on the mounting plate and secure both harnesses to the left outer mounting plate (Fig. 3) Note the orientation of the switch and wire colors for proper operation.

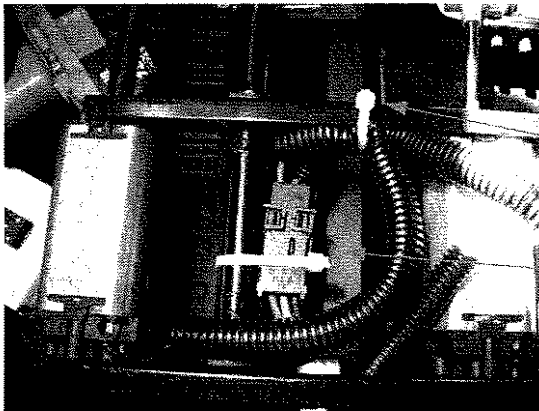
Fig. 4

Tie #5
Secure motor plug
to round steel cross
member, tie
harnesses to internal
seat base structure.
Tie # 4

11. Position the motor plug to forward round cross tube & secure with a wire tie. (Fig. 4)
12. Secure two wire harness to inner structure of seat base with wire tie (Fig. 5)

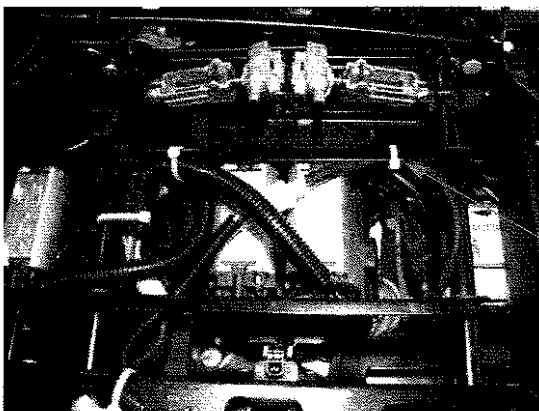
Fig. 5

Ensure all cables are
clear & secure. Test
operation in all
directions confirming
no interference with
wiring.
Tie #6

This photo shows the
complete work, prior
to seat reinstallation.

13. Check for full, unrestricted travel, for and aft, up and down.
14. Reposition drivers seat over base. Pass 6 way controller through hole in seat flange. Secure seat to base and 6 way controller to seat flange.
