# FLEET OPERATIONS

February 28, 2014

## Attention: BC Ambulance Service Representative

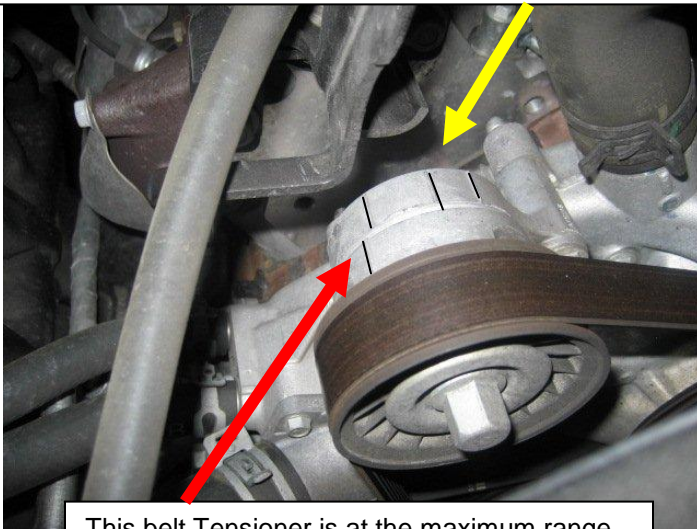
There have been instances on the Chevrolet gasoline engine ambulances where the serpentine belt prematurely wears and emits an audible chipping noise. Due to inconsistencies during manufacturing, ambulance manufacturers may have installed an incorrect sized idler pulley between the two alternators.

Belt Tensioner hash mark needs to be in the middle range

At the next scheduled A service inspect the serpentine belt tensioner for correct positioning.

If your Chevrolet gasoline engine belt tensioner has exceeded the maximum position as shown in the picture – Contact the ambulance manufacturer (Crestline or Demers) for the correct idler pulley (and belt) for warranty replacement.

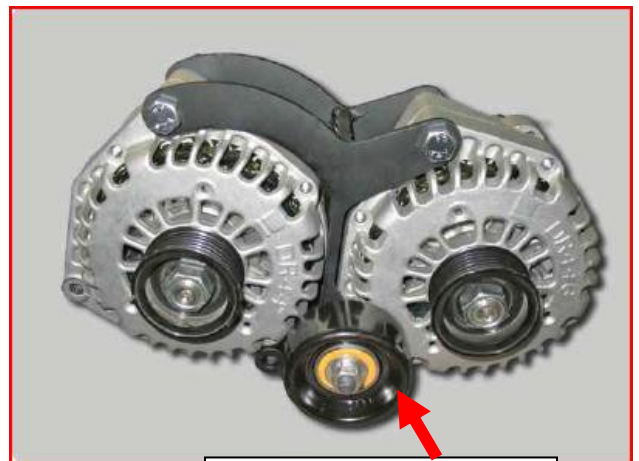
This belt Tensioner is at the maximum range

Idler pulley in question
