BC Ambulance Service BC Emergency Health Services	321-15	January 5, 2016 Page 1 of 4
AMBULANCE TYPE:	DEMERS FIRST YEAR DUAL STRETCHER	
UNITS AFFECTED:	63080 TO 63092

ISSUE: THE POSITIONING OF THE YELLOW SAFETY HOOKS ON THE FIRST YEAR DEMERS DUAL STRETCHER AMBULANCES MAY RESULT IN THE HOOKS NOT CATCHING CORRECTLY WHEN LOADING OR UNLOADING COTS. THE ISSUE MAY ARISE WHEN THE COT STRADDLES BOTH HOOKS, WHERE ONE HOOK WILL RAISE THE STRETCHER CATCH BAR MISSING THE SECOND HOOK.

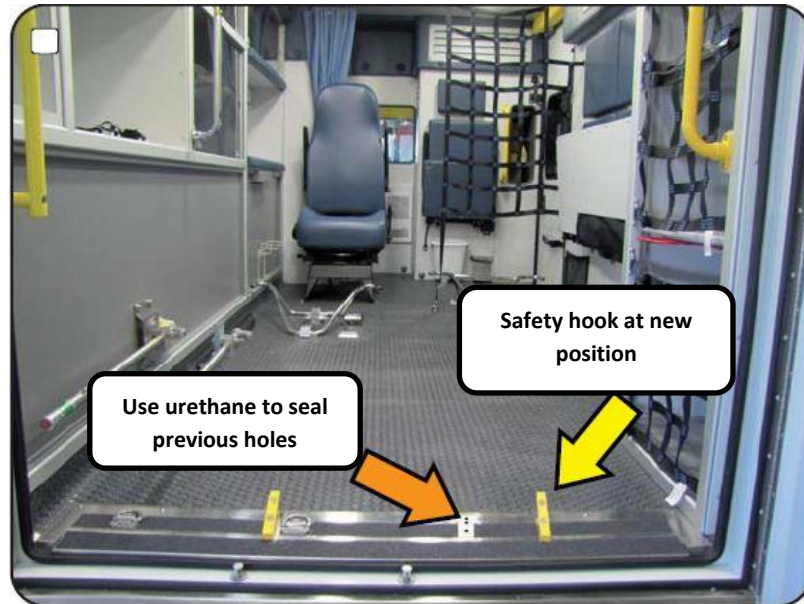
Figure 3

IMPORTANT: If there is a gap under the vehicle that shows some plywood, moisture will catch and it will rot.

8. Inspect from the underside and ensure that the urethane is applied all the way through to the floor. The urethane being white in color should be easily visible from the underside.
