FLEET OPERATIONS

SAFETY NOTIFICATION

Demers Ambulance Fold-out Step Inspection

Affected Units: Demers Ambulance unit numbers **63030 to 63092** with a flip step.

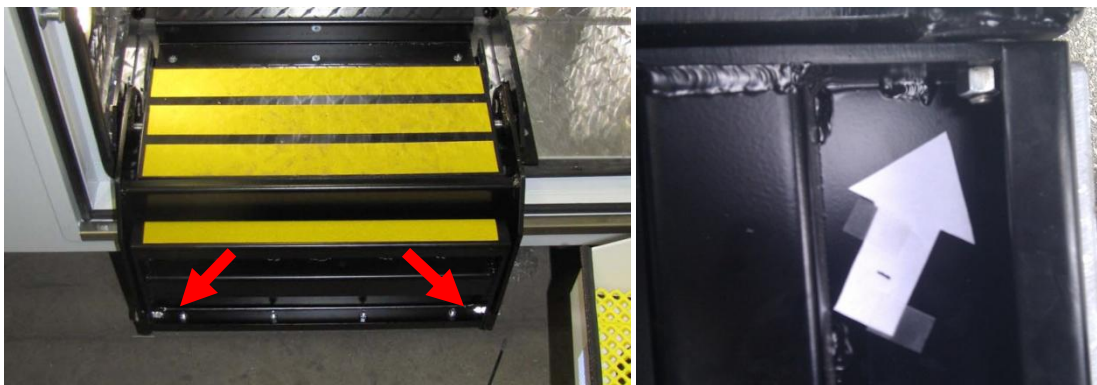
Figure 1: Location of Pivot Bolts

Issue: Some fold-out side steps may have been incorrectly assembled with a standard nut instead of a nylon locking nut. With use, standard nut assembly may loosen and potentially render the fold out step unusable. Units must be inspected to ensure the proper locking nuts where installed.

Unit Chiefs - Inspect the fold out step hinge points (indicated with red arrows) ensuring the proper nylon lock nut was utilized and that it has not loosened off. Nylon locking nuts can be identified by the white plastic ring around shaft of the bolt. (Please refer to Figure 2)

If the step is not assembled with a standard nut, please arrange to have the nuts replaced with nylon locking nut at your designated service center.

If side steps has been assembled with standard nuts, remove and replace these nuts with a 3/8"-16 Nylon locking nut. Nylon lock nuts may be sourced locally or if required may be requested from Demers Ambulance by contacting their warranty line at 1-855-373-9789.
