Demers Chevrolet 6.0 L Gas Engine

62911 – 62979 63030 - Current

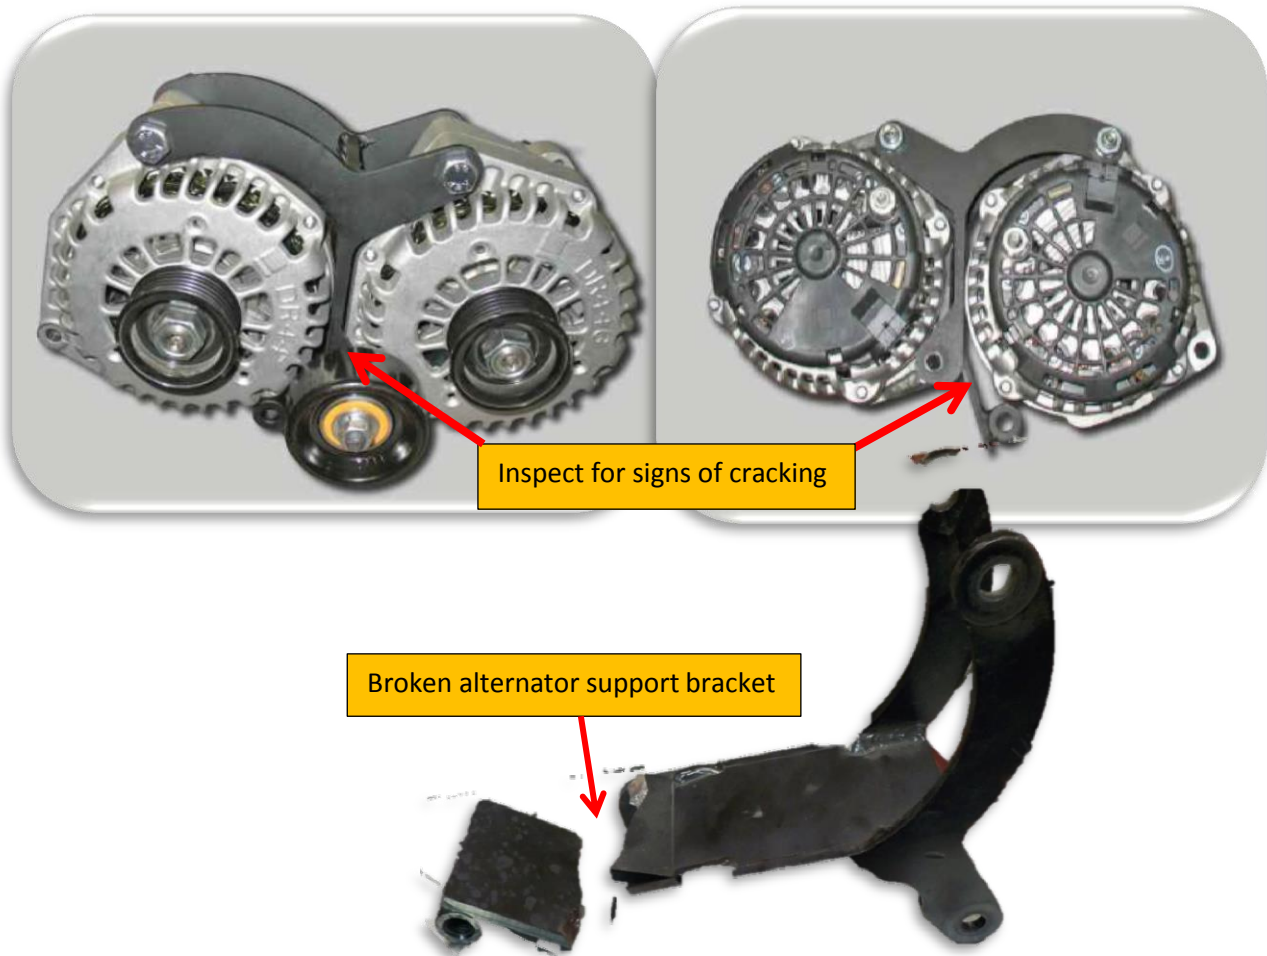
ISSUE: It has been brought to BC Ambulance Fleet Operations attention that the dual alternator support bracket may crack and break.

To properly inspect the bracket, the belt and idler pulley may need to be removed.

ACTION: If there are abnormal vibration noises heard from the engine compartment at varied engine RPMs, inspect the alternator support bracket for cracks or breakage.

If the alternator bracket is determined to have a crack or breakage, contact Demers warranty (1-855-373-9789) for the warranty part replacement.
