FLEET OPERATIONS

February 28, 2014

Attention: BC Ambulance Service Representative

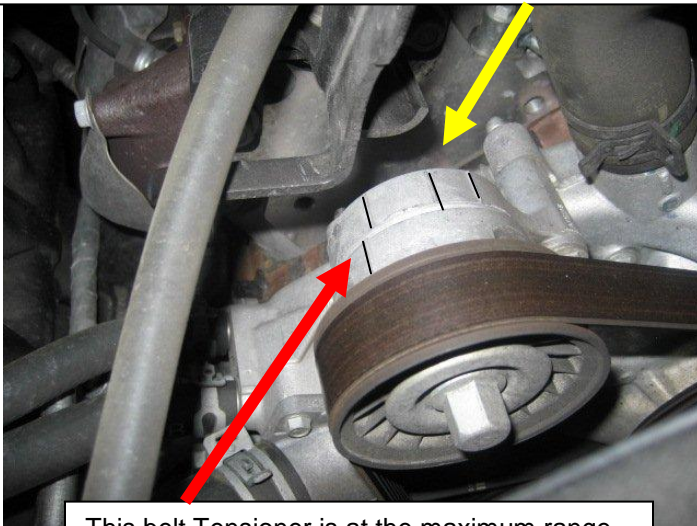
There have been instances on the Chevrolet gasoline engine ambulances where the serpentine belt prematurely wears and emits an audible chipping noise. Due to inconsistencies during manufacturing, ambulance manufacturers may have installed an incorrect sized idler pulley between the two alternators.

Belt Tensioner hash mark needs to be in the middle range

At the next scheduled A service inspect the serpentine belt tensioner for correct positioning.

If your Chevrolet gasoline engine belt tensioner has exceeded the maximum position as shown in the picture – Contact the ambulance manufacturer (Crestline or Demers) for the correct idler pulley (and belt) for warranty replacement.
