**British Columbia
Ambulance Service**
Emergency and Health Services Commission

Memorandum

Re: Stair Chair Restraint Belt Anchor Relocation - Crestline

GMOCCBR—Stair Chair Belt Re-location

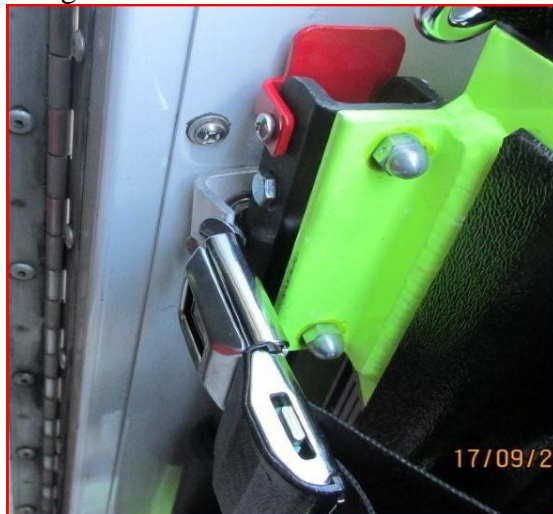
Original Installation

To prevent damage to stair chairs from abrasion, the mounting hardware for the restraint belt must be relocated. BCAS Fleet Operations request the following procedure to be performed to all Crestline built vehicles. **Demers built Ambulances do not apply.**
