| | <b>OEM AC COMPRESSOR ACTIVATION<br/>SERVICE BULLETIN</b> | <b>UP 084 REV 0<br/>2011-09-19</b> |

AMBULANCE TYPE:      MX151D 2010 (Unit: 62911 to 62922)

This bulletin is to inform owners of Demers Ambulances that a modification of the OEM air conditioning activation system is required. Activation of the OEM air conditioning system was performed by activating only the chassis compressor. This modification will activate the OEM air conditioning taking in consideration all the OEM protection.

| TITLE :<br>AIR CONDITIONING MODIFICATION<br>MX151D 2011 SERIES 629XX | | | |

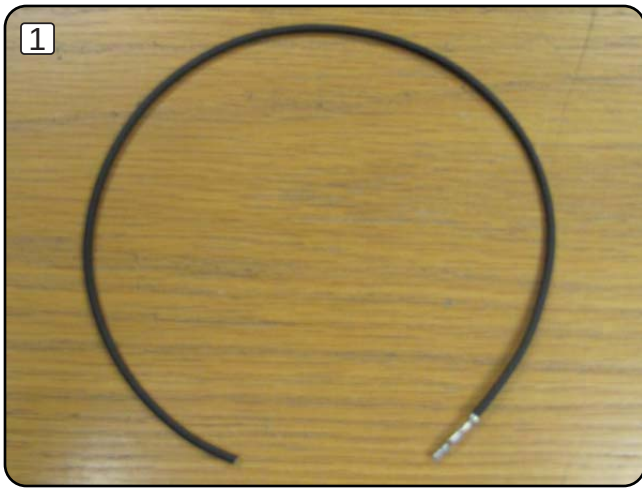
Use the supplied harness # H020248 with female connector to make the modification.

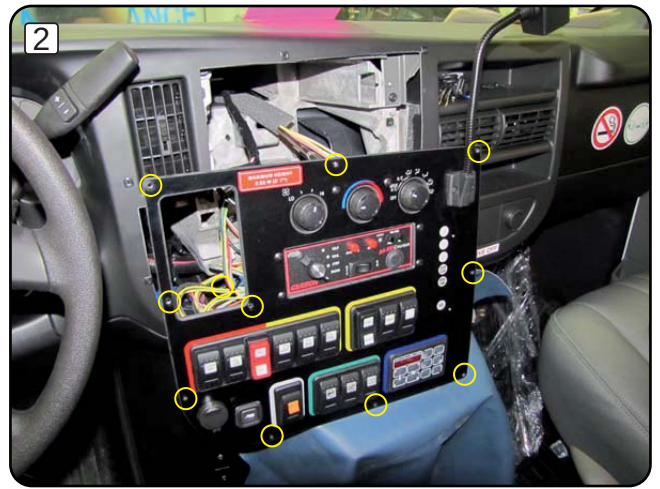
To remove the console panel, locate and unscrew the ten (10) screws as shown.

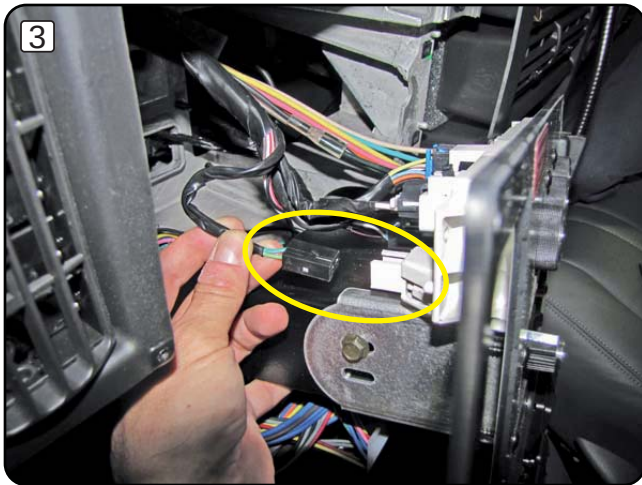
Locate the 2 position connector with the green wire and the light green wire connected behind the gm climate control module as shown.

Pull the connector to disconnect it.

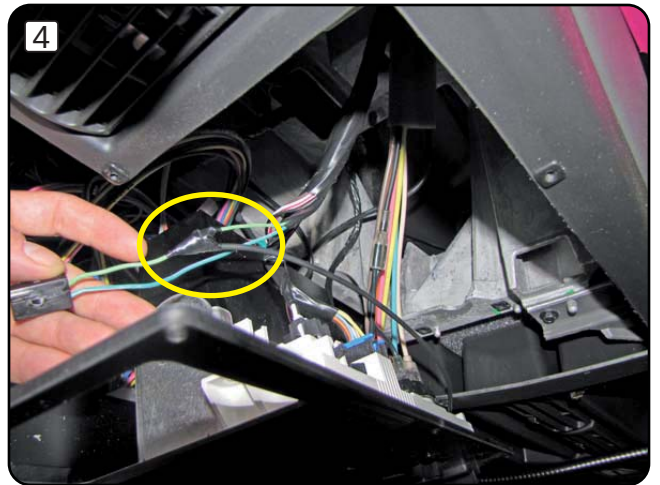
Weld the new black wire with the light green wire.  
Insulate the soldering with electrical tape.  
(see drawing # 1)

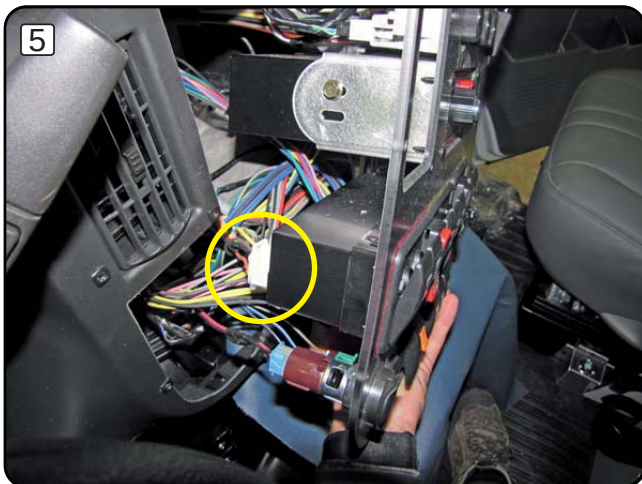
Locate the 9 position connector connected behind the switchplex as shown.

Pull the connector to disconnect it.

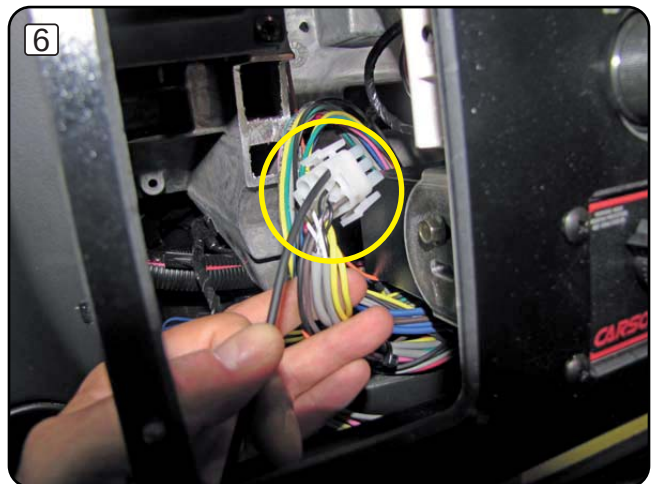
Connect the new black wire in position 9 of the switchplex connector.  
(see drawing # 1)

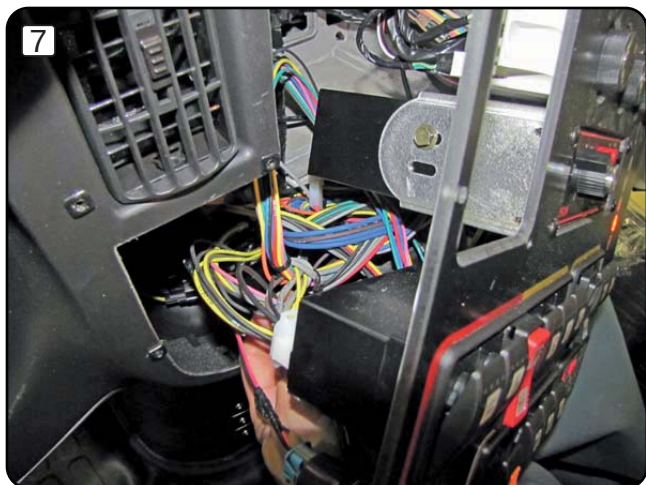
Reconnect the 2 position connector with the green wire and the light green wire.  
Reconnect the 9 position connector.

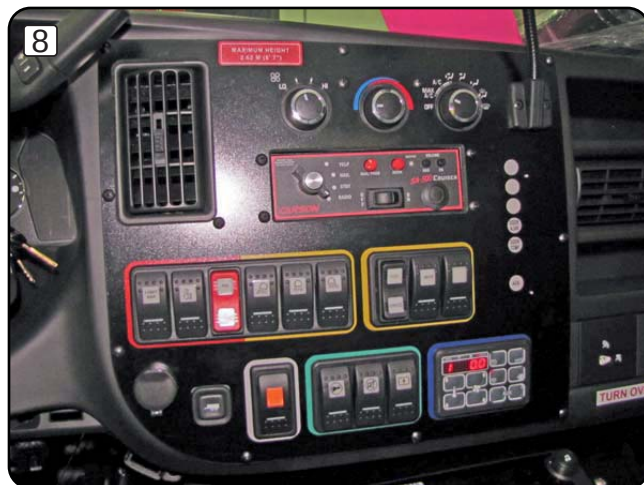
Reinstall the console panel.
