**AMBULANCE TYPE:** DEMERS MX151D-BCAS

**UNITS AFFECTED:** 63030 - 63079

**ISSUE:** Garbage is falling behind flip out garbage bin preventing adequate decontamination of area.

**ACTION:** Remove existing bin & hardware and replace with removable trash bin.

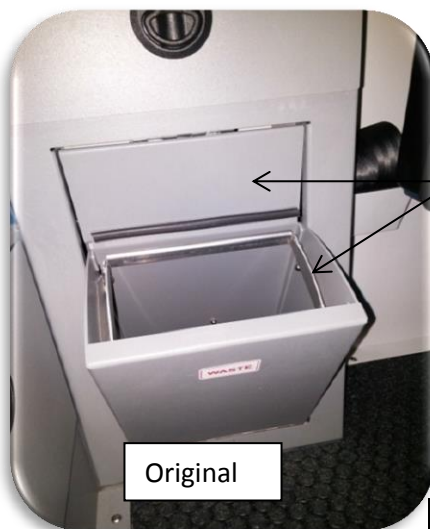
Original

Bin and flap door  
to be removed.
