Stair Chair Bracket and Squad Bench Bolster Modification

To All BC Ambulance Unit Chiefs

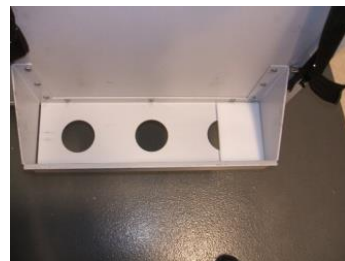
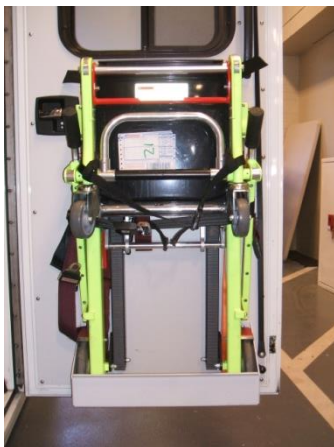
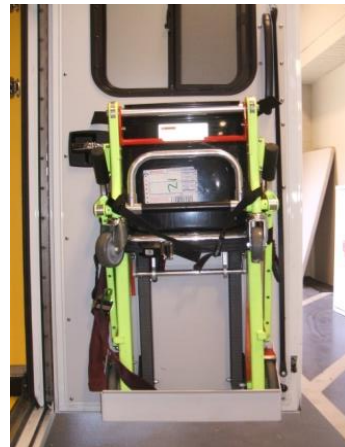
Stair chair bracket modification (Refer to pictures).

BC Ambulance Fleet Operations has found that the squad bench end bolster upholstery and the right side patient door jam and seal are being damaged by the stair chair that is mounted on the right side patient compartment door. Please follow these instructions for the repair procedures.

- Remove the stair chair from the right side patient door.
- Remove the yellow plastic mat at the bottom of the stair chair bracket and **discard**.
- Wipe clean the inside bottom of the Stair Chair bracket.
- Peel the tape adhesive cover from the supplied plastic block and stick the block to the right inside end of the bracket.
- Re-install stair chair.

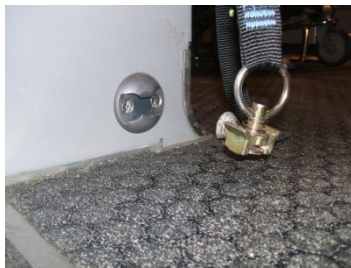
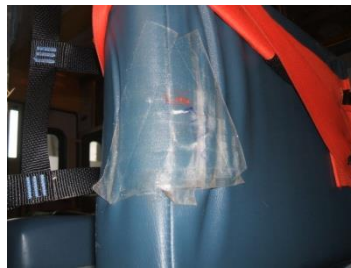
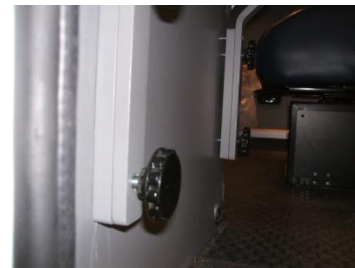
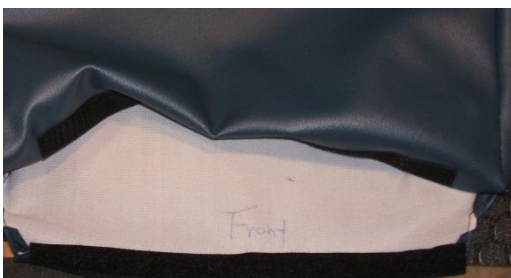
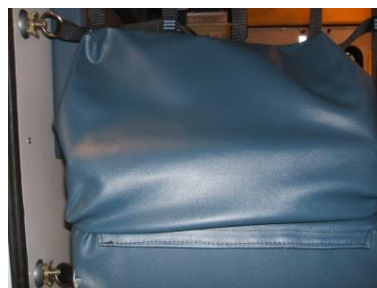
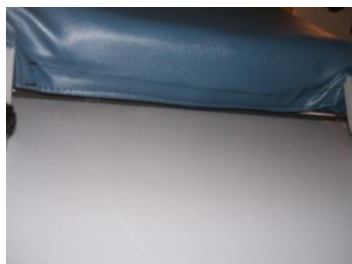
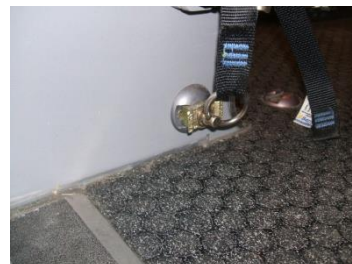
Squad bench end bolster upholstery repair (Refer to pictures).

Please inspect the squad bench end bolster for any tears. If the bolster is torn, contact BCAS Fleet Operations at 1-877-652-7465 (option 1) and order a cover for the affected unit(s).

- Detach the safety restraint net in front of squad bench bolster at the buckle located on the right lower mount near the floor. Move net away from bolster.
- Remove any tape or protective straps on squad bench end bolster.
- Clean off any tape residue on bolster cushion vinyl.
- Loosen squad bench bolster retaining thumb screws
- Slide the supplied slip cover over the bolster, be sure to identify the front of the slip cover (front facing to the front of the ambulance). Slide the slip cover over the bolster evenly being careful not to tear the seams.
- Secure the Velcro on the bottom side of the slip cover.
- Re-tighten the bolster thumb screws.
- Re-attach the safety restraint net.
