AMBULANCE TYPE: MX151D Units: 63030 to 63092, 63100 to 63164, 63200 to 63264

This bulletin is to inform owners of Demers Ambulances (unit numbers listed above) that a modification of wiring harness is required. Front fender intersection lights are activated with the left/right flasher and with emergency lights. Modification will consist of removing left/right flasher feature but emergency lights feature will remain functionnal.

INTERSECTION LIGHT « STEADY-BURN » DEACTIVATION FEATURE (UNIT 63030 TO 63092, 63100 TO 63164, 63200 TO 63264)

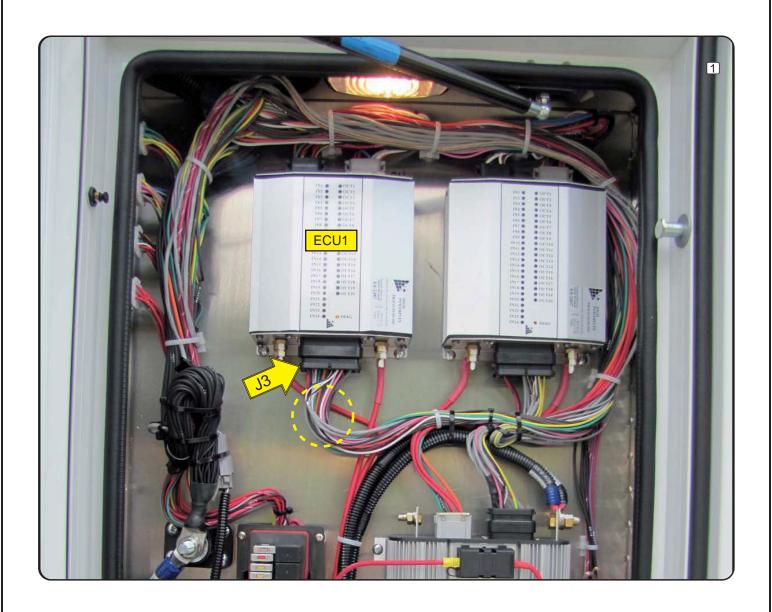
- 1 Locate connector J3 on module ECU-1.
- 2 Remove connector J3 and locate pin 7 left flasher / pin 8 right flasher (see diagrams on page 2)
- 3 Cut and insulate wires at both ends on pins 7 & 8 (yellow & green wires)
- 4 Reinstall connector J3 on module ECU-1.

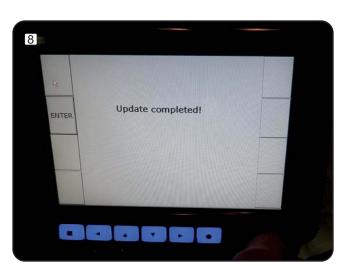
Click on the ENTER icon.

Wait for confirmation message before proceeding to next step.
