MODULAR BODY STRUCTURE MODIFICATION SERVICE BULLETIN	UP 094 REV 2 2012-07-03
		Page 1 of 1

AMBULANCE TYPE: MX151D 2009 – 2010 – 2011 (62800 to 62899) and (62911 to 62980)

This bulletin is to inform owners of Demers Ambulances that a modification of the modular body structure is required. The rear leaf springs clip may contact the ambulance body structure.

REAR SPRING UPGRADE MODIFICATION

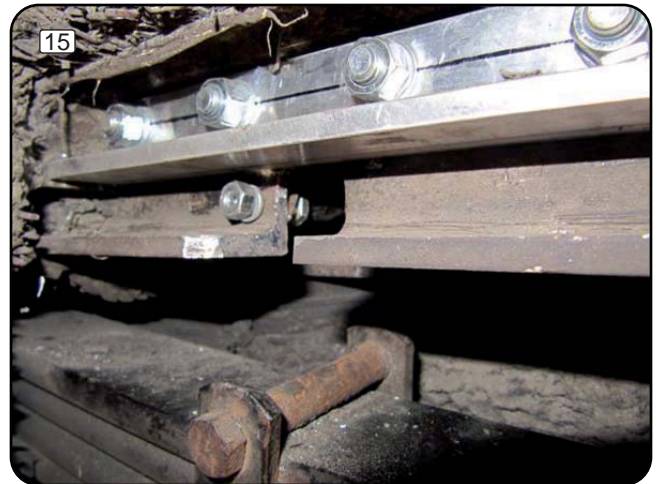
View of the installed clamp.
