BC Ambulance Service
BC Emergency Health Services

175-15 Rear Door Garbage BIN MODIFICATION

AMBULANCE TYPE: DEMERS MX151D-BCAS

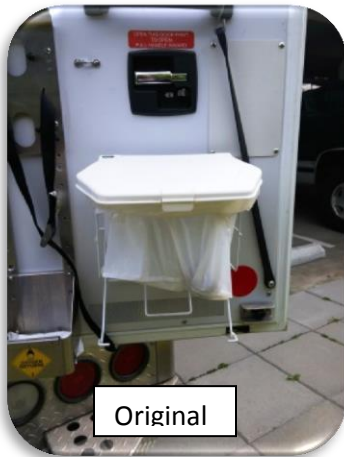
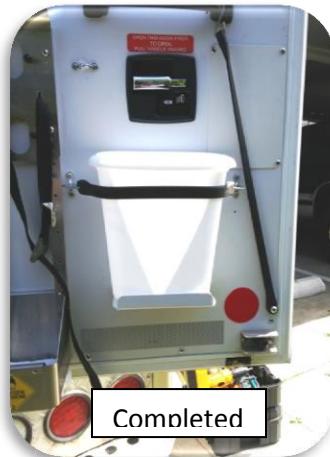
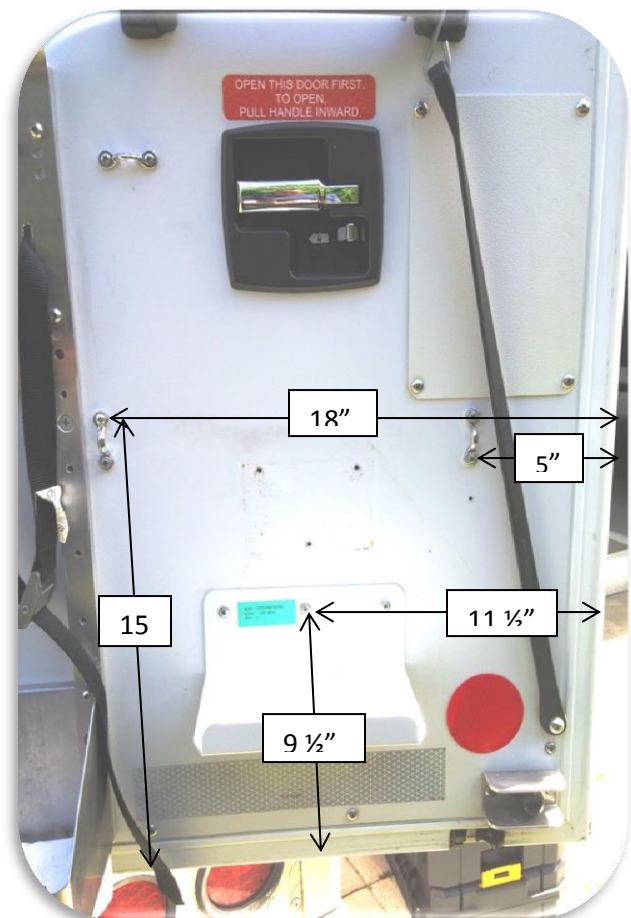
ISSUE: Rear door wire garbage bag holders are failing in service.

1. Remove old hardware
2. Drill 1/8" holes at locations shown
3. Mount shelf & pad eyes with screws provided
4. Install bin and retaining strap

ACTION: Replace existing wire bag holder with removable hard shell bin & support shelf

Shelf, Bin, strap, 2 pad eyes,
7 - #8 self-tapping screws
