**British Columbia
Ambulance Service**
Emergency and Health Services Commission

Memorandum

Re: Stair Chair Restraint Belt Anchor Bolt Upgrade - Demers

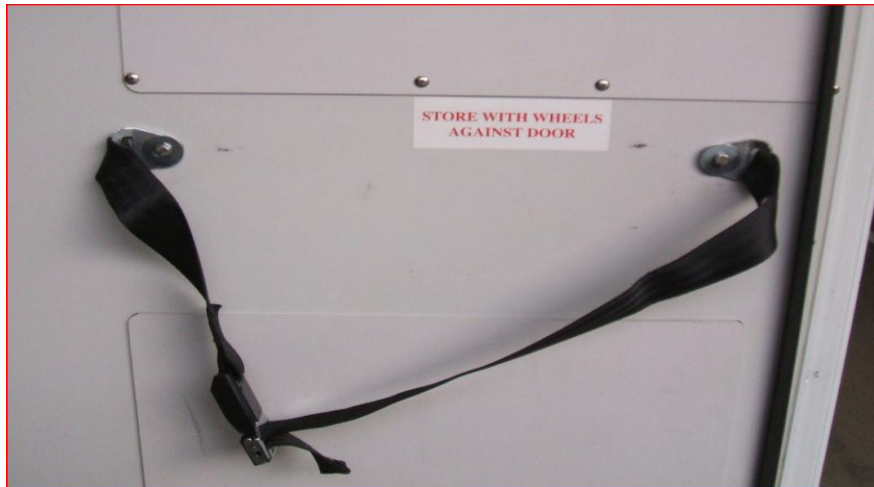
To prevent loosening of restraint belt for stair chairs, the mounting hardware for the restraint belt must be updated. BCAS Fleet Operations request the following procedure to be performed to all Demers built vehicles 62800 - 92981. **Crestline built vehicles do not apply.**

Belt anchors must be installed pointing toward outside edges of the door. (See picture)

Remove the screw holding the stair chair belt from right and left side of side patient door and discard screws.

Drill 25/64" holes into door at existing screw hole locations.

Install the supplied Nutsert and reinstall the belt using supplied hardware with lock tight.
