<b>BC Ambulance Service</b> BC Emergency Health Services	<h2>Yellow Grab Handle Removal</h2>	May 14, 2018 Page 1 of 1
<b>AMBULANCE TYPE:</b>	<b>Demers and Crestline</b>	
<b>UNITS AFFECTED:</b>	<b>All Units Equipped with a Yellow Grab Handle Inside the Left Rear Door</b>

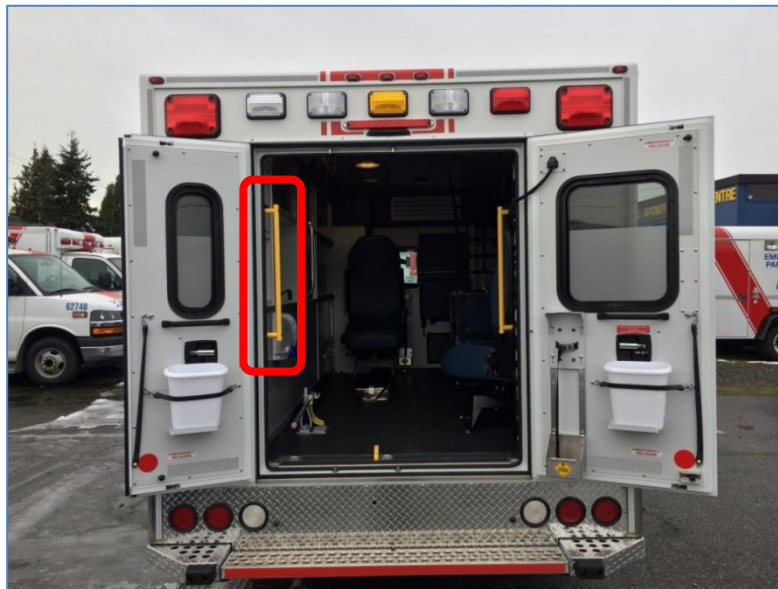
**ISSUE:** The yellow grab handle located inside the left rear door interferes with the patient when loading or unloading.

1. Identify the yellow grab handle inside the left rear door. Refer to picture below.

**ACTION:** At the next scheduled "A" service, remove the yellow grab handle and discard.

2. Using the appropriate tools, remove the handle.
3. Plug the exposed bolt holes with the push retainer pins ordered from Lordco, or equivalent parts supplier P/N: 18771. Apply a small amount of clear silicone to the push pins to further secure the push pins.
4. Dispose of the removed handle.
