<b>POWER STEERING RESERVOIR SUPPLY HOSE SERVICE BULLETIN</b>	<b>UP 110 REV 3 2014-06-12</b>
		<b>Page 1 of 3</b>

AMBULANCE TYPE: MX151D – MX163D

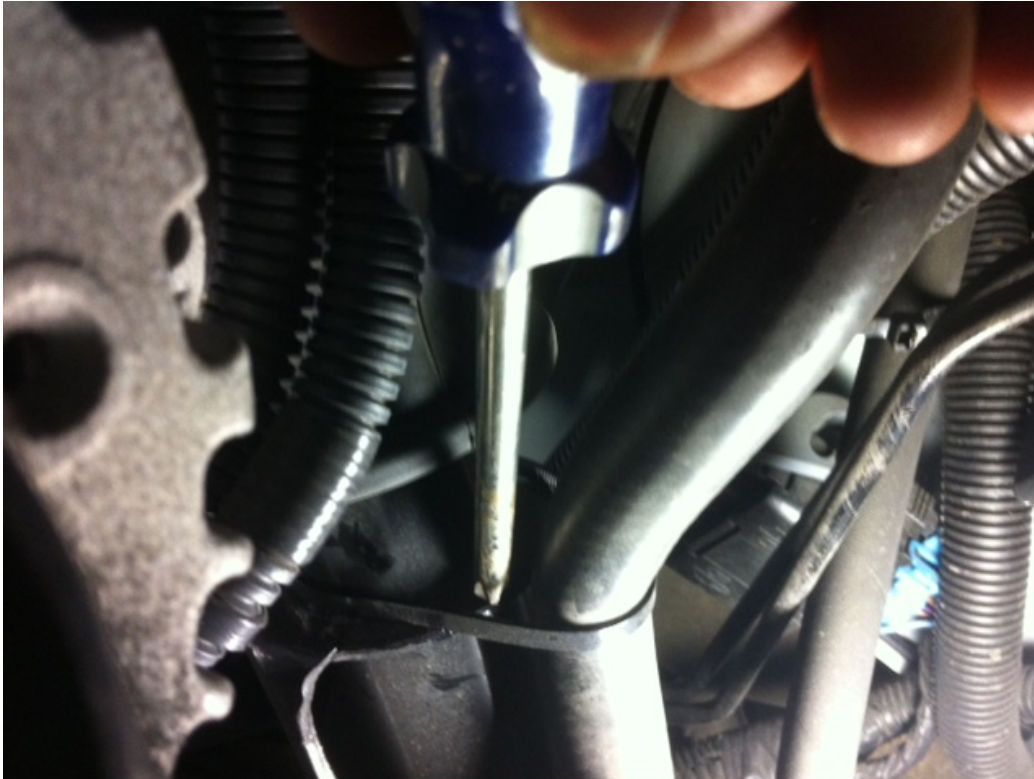
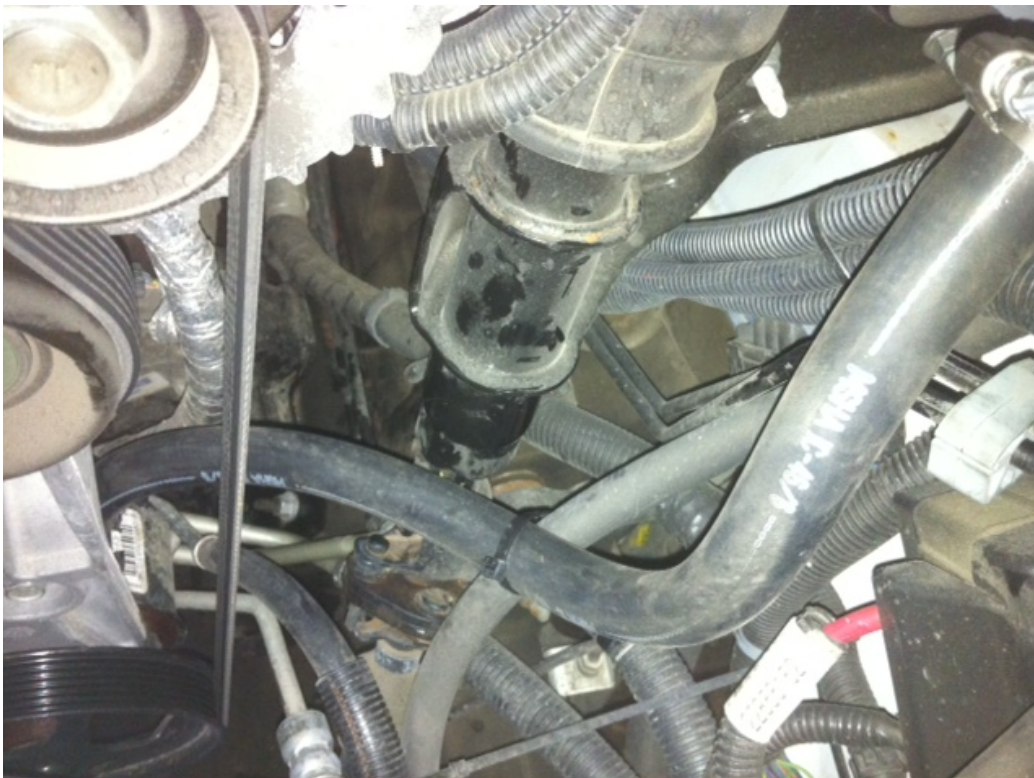
This bulletin is to inform owners of Demers Ambulances that a modification of the Power Steering reservoir hose is required. It has been brought to our attention that the power steering supply hose that is secured to the steering column has potential to rub through the column support rib. (See photos attached)

The original power steering hose is about 20" long and too short to reroute, Purchase 28" of 5/8 hose from Lordco (part # H10110) or equivalent. To complete the repair drain the reservoir, replace the hose routing and fastening as detailed in the picture. Re-bleed the power steering system and check for leakage and interference.

**NOTE: Please make sure the hose is routed in such a way that it will not rub against accessory drive belt (like the alternator belt).**
